USAF Weapon System Evaluation Program

Task Report – Naval Research Laboratory Contract N00014-97-D-2014/001

MAVERICK MISSILE LAUNCH ANALYSIS WSEP 98-02

MAVERICK MISSILE LAUNCH ANALYSIS WSEP 98-03 and WSEP 98-06

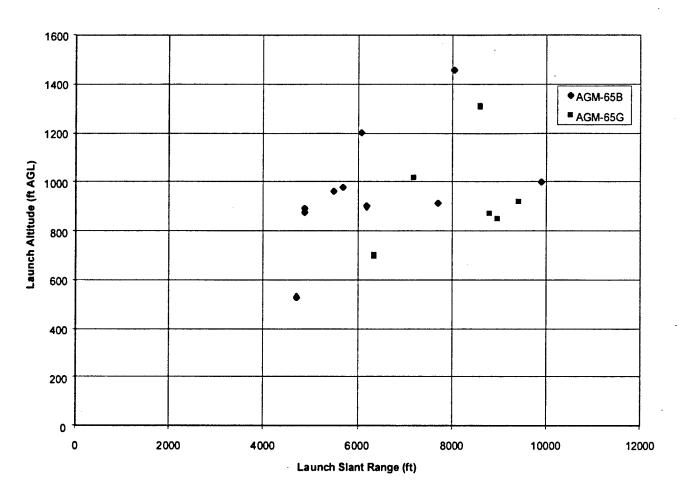
FIGURE 2.0.1

¹ Missile locked onto and tracked ground fire. Track was stable throughout missile flight with missile overflying target.

WSEP 98-02 LAUNCH PARAMETERS

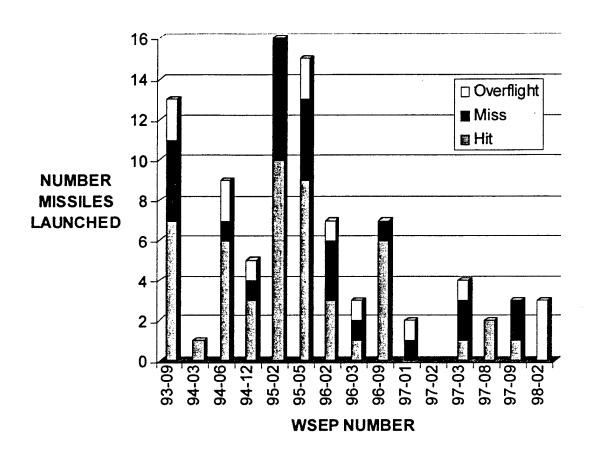
FIGURE 4.1.1

Since 1993, over fifteen percent of the AGM-65G Maverick missiles launched in the point track (centroid track) against small (tank size) targets during WSEP have overflown the intended target. To date the cause of this problem has not been conclusively identified. Table 4.1.1 below summarizes AGM-65G Maverick missile launches since 1993.

AGM-65G WSEP RESULTS

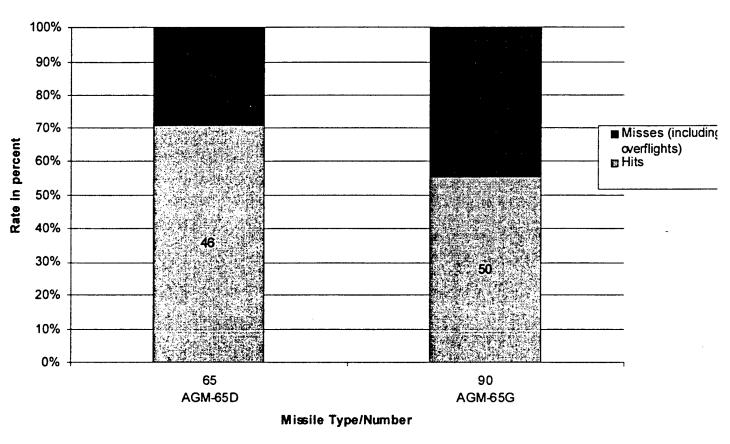
FIGURE 4.1.2

Figure 4.1.2 below depicts AGM-65D and AGM-65G hit/miss rates (where overflights are considered to be a subset of misses).

AGM-65D and AGM-65G WSEP HIT/MISS RATES (Misses include overflights)

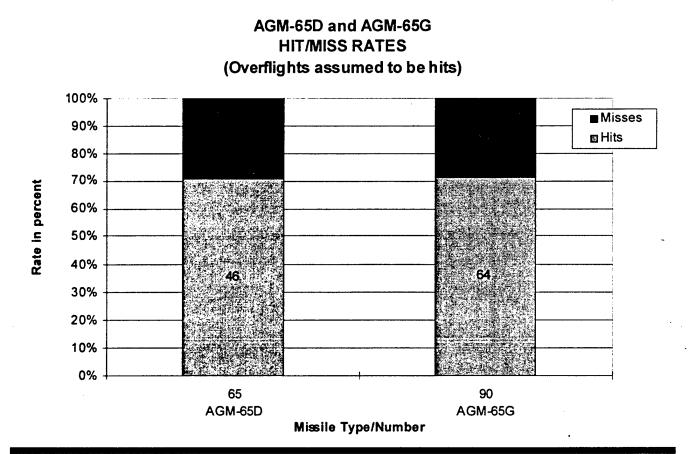
FIGURE 4.1.3

Figure 4.1.3 below depicts AGM-65D and AGM-65G hit/miss rates when all AGM-65G overflights are reclassified as hits. The assumption that AGM-65G overflights can be reclassified as hits for comparison purposes is supported by the fact that all missiles that overflew the intended target were performing properly and tracking prior to exhibiting the overflight anomaly.

Figure 4.1.3 shows that the AGM-65D and AGM-65G hit/miss rates (<u>AGM-65D</u>: .708 hit / .292 miss; <u>AGM-65G</u>: .711 hit / .289 miss) are <u>statistically similar when AGM-65G overflights</u> are <u>reclassified as hits</u>. This data confirms that the AGM-65G overflight problem is significant and is adversely impacting the overall performance of the AGM-65G Maverick missile system.

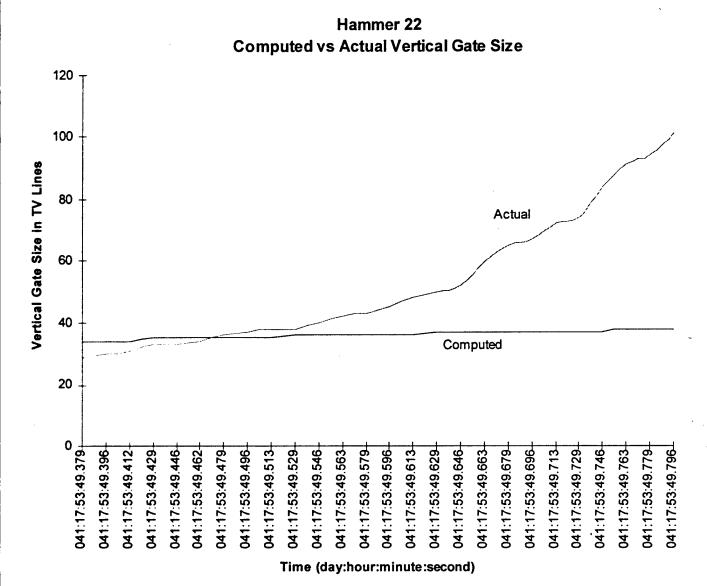
FIGURE 4.2.7

Figure 4.2.7 depicts the computed vertical gate size versus the actual gate size for Hammer 22.

It is readily apparent from Figure 4.2.7 that when the actual target size growth rate exceeds the target tracking gate growth rate, the missile will then be tracking an erroneous target centroid because the missile is improperly calculating the actual target vertical and horizontal centerlines. Testing at the Guided Weapons Evaluation Facility (GWEF) at Eglin AFB, Florida has confirmed that the AGM-65G tracking gates appear to grow at about one-third the rate at which the AGM-65D tracking gates grow for the same target. The AGM-65D and AGM-65G Computer Program Product Fabrication Specifications, however, show that the tracking growth rate equations are identical and hence the AGM-65G should exhibit target gate growth rates identical to the AGM-65D.

Testing conducted at the Guided Weapons Evaluation Facility confirmed that the AGM-65G target tracking gates grow at about one-third the rate at which the AGM-65D target tracking gates grow for an identical target.

Additional analysis should be accomplished to further quantify the extent of the overflight problem throughout the employment envelope of the AGM-65G. Further study to define the exact cause of the target tracking growth error should be conducted.

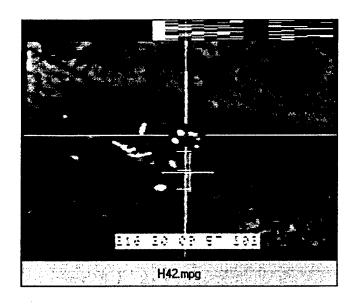
One missile (Hammer 42, Day 2) broke lock on at or just after launch. The telemetry data for this missile is incomplete; therefore no definitive cause of the break lock was determined. Figures 3.1.1 through 3.1.3 are the only video frames available of the break lock sequence for this missile. Note in Figure 3.1.1 that there are multiple targets within the tracking gates. In Figure 3.1.2 the

Hammer 42 Break Lock Video (First Frame)

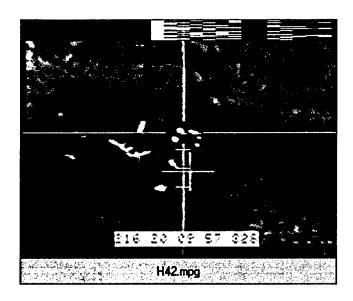
Figure 3.1.2

targets have shifted slightly. In Figure 3:1.3 the tracking gates have closed and the targets have moved below the gates.

Hammer 42 Break Lock Video (Second Frame)

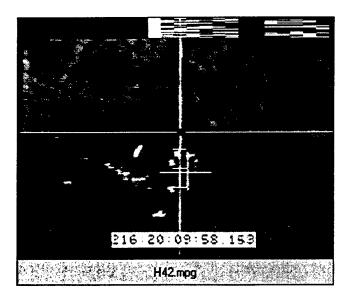
Figure 3.1.3

Hammer 42 Break Lock Video (Third Frame)

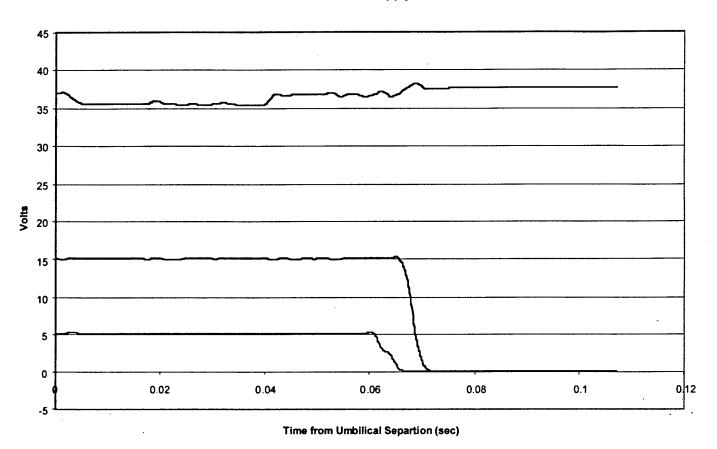
Figure 3.2.7

Hammer 35, Day 1 and Hammer 33, Day 2 both exhibited a similar failure mode. Telemetry and video data for these missiles were analyzed to determine the most likely failure. In each case it

was observed that both the 5-volt late and 15-volt late power supply values simultaneously went to 0 volts almost immediately after weapon umbilical separation. In both cases the missile battery voltage remained stable.

Hammer 35's failure occurred at approximately 22 milliseconds after umbilical separation, and Hammer 33's failure occurred at approximately 60 milliseconds after umbilical separation. Figures 3.2.6 and 3.2.7 respectively show Hammer 35 and Hammer 33 power supply values immediately after umbilical separation.

Hammer 33 Power Supply Values

This failure mode is similar to failures observed in AGM-65G missiles where circuit cards were dislodged during launch acceleration. For the two failures under investigation, it was concluded that the Power Supply Assembly (PSA) circuit cards were dislodged shortly after launch. In both the AGM-65D and the AGM-65G missile, the PSA card is the heaviest card (approximately 1.5 lbs.) in the card assembly. It has also been observed in previous missile firings that AGM-65G torquer amplifier cards have become dislodged at or shortly after launch.

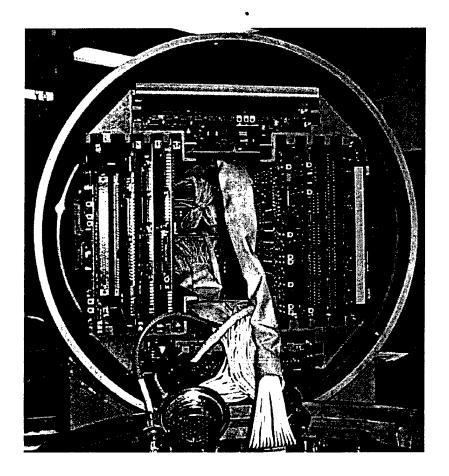
During production of the AGM-65G, an engineering change was made to the missile that removed the circuit card retainer plate. The common factor observed in the majority of the AGM-65G failures at launch, or shortly thereafter, is the lack of this circuit card retainer plate. While it is common knowledge that many AGM-65G Maverick missiles were produced without the card retainer plate, it was not known generally known how many, if any, AGM-65D Maverick missiles were produced without the retainer plate. A search of available Air Force databases revealed that approximately 1300 AGM-65D Maverick missiles have been produced without the circuit card retainer.

Figure 3.2.8 illustrates the AGM-65D/G circuit card installation without the retainer plate. The Power Supply Assembly (PSA) card is the bottom card behind the cables. The Torquer Amplifier card is the right-most card.

The lack of the circuit card retainer card in some AGM-65D missiles may contribute to an increased failure rate as the inventory is depleted and later year manufactured missiles are expended.
